WEST PARK HISTORIC DISTRICT
DESIGN GUIDELINES

HISTORICAL ARCHITECTURAL REVIEW BOARD
APRIL 2001

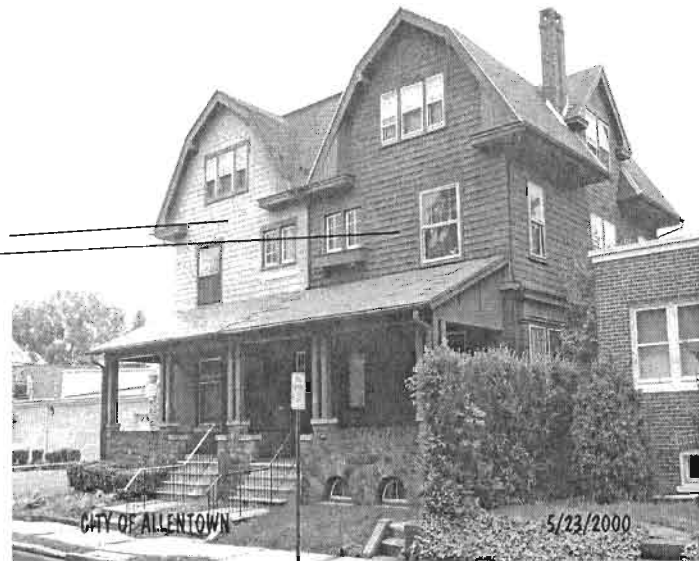
Shingle

- Wooden shingle is the predominant wall cladding material

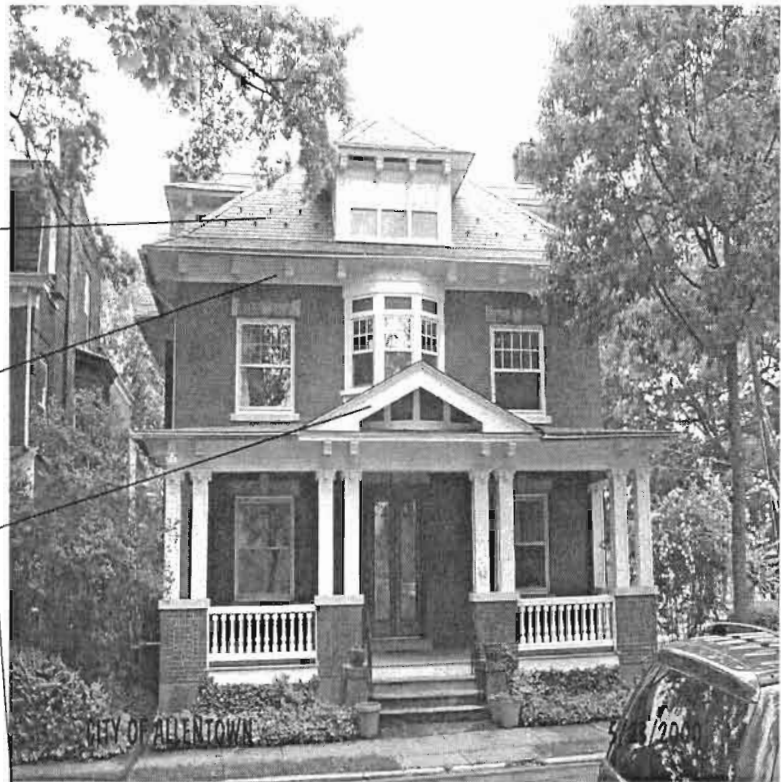
Colonial Revival

- Gambrel roof
- Hipped roof
- Pediment dormers
- Modillion at roofline, bay, porch
- Divided upper sash windows
- Pediment at entry
- Classical columns at porch
- Quoins at building corners
